Windstorm Mitigation Report (OIR-B1-1802)

Cypress Run Condominium Association, Inc.

Bldg 1, 1 Cypress Run, Units 11A-16C

As of 02-17-2026 | FPAT File# MUD2626471

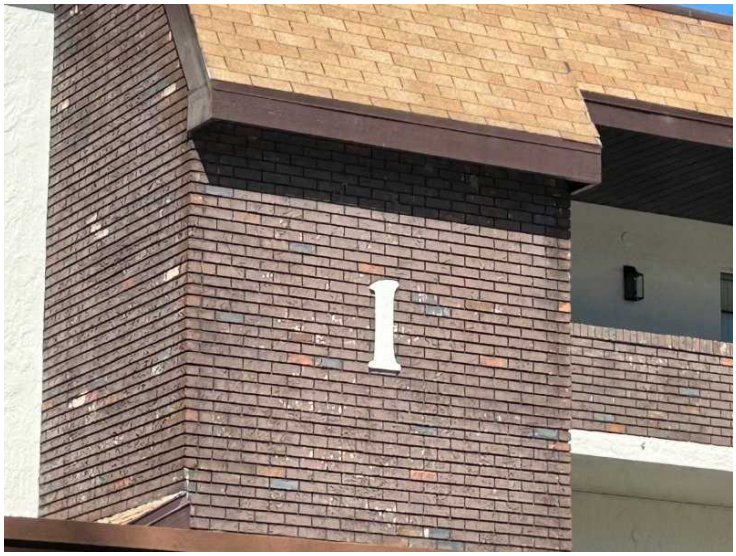
Address Verification

Exterior Elevation

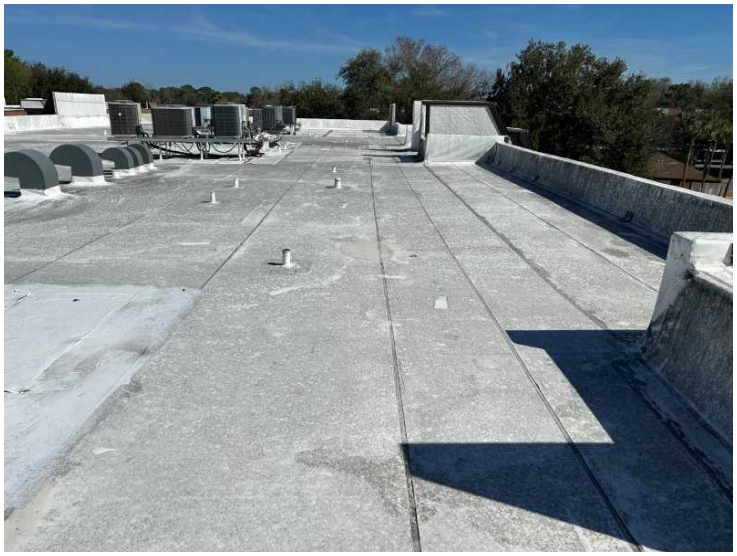
4. **Roof to Wall Attachment:** **Toe Nails**
   Comments: Inspection verified embedded straps fastened with less than three nails.

Roof Construction
