Windstorm Mitigation Report (OIR-B1-1802)

Cypress Run Condominium Association, Inc.

Bldg 2, 2 Cypress Run, Units 21A-26C

As of 02-17-2026 | FPAT File# MUD2626471

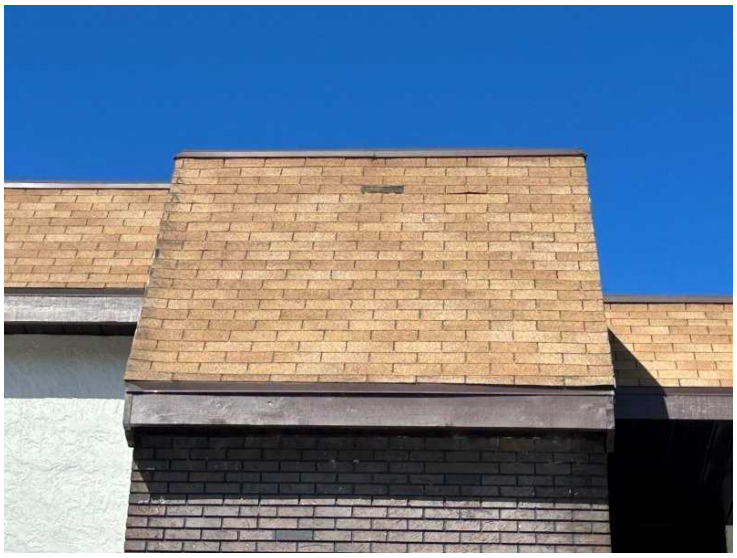
Roof Construction

3.	**Roof Deck Attachment:**	**Level A**
	Comments:	Inspection verified 1/2" plywood roof deck attached with staples at a minimum of 6" on the edge & 12" in the field.

4.	**Roof to Wall Attachment:**	**Toe Nails**
	Comments:	Inspection verified embedded straps fastened with less than three nails.
5.	**Roof Geometry:**	**Flat Roof**
	Comments:	Inspection verified a mansard roof shape.
