Windstorm Mitigation Report (OIR-B1-1802)

Cypress Run Condominium Association, Inc.

Bldg 3, 3 Cypress Run, Units 31A-36C

As of 02-17-2026 | FPAT File# MUD2626471

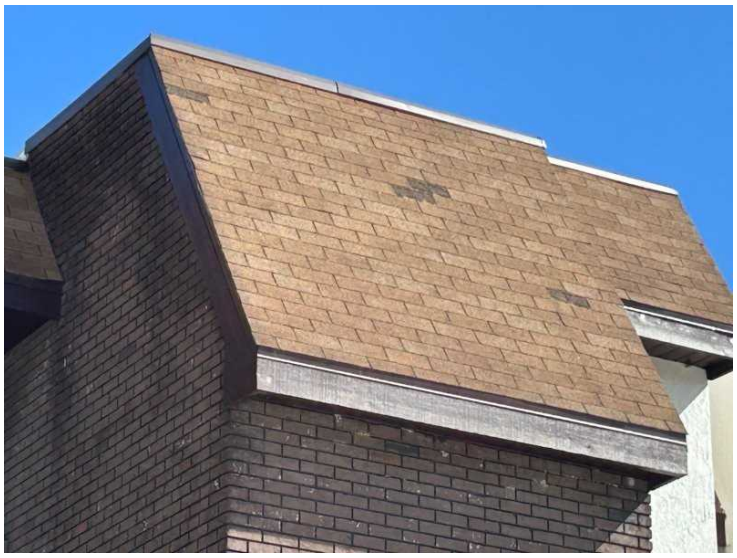
3.	**Roof Deck Attachment:**	**Level A**
	Comments:	Inspection verified 1/2" plywood roof deck attached with staples at a minimum of 6" on the edge & 12" in the field.

4.	**Roof to Wall Attachment:**	**Toe Nails**
	Comments:	Inspection verified embedded straps fastened with less than three nails.
5.	**Roof Geometry:**	**Flat Roof**
	Comments:	Inspection verified a mansard roof shape.
