Windstorm Mitigation Report (OIR-B1-1802)

Cypress Run Condominium Association, Inc.

Bldg 4, 4 Cypress Run, Units 41A-46C

As of 02-17-2026 | FPAT File# MUD2626471

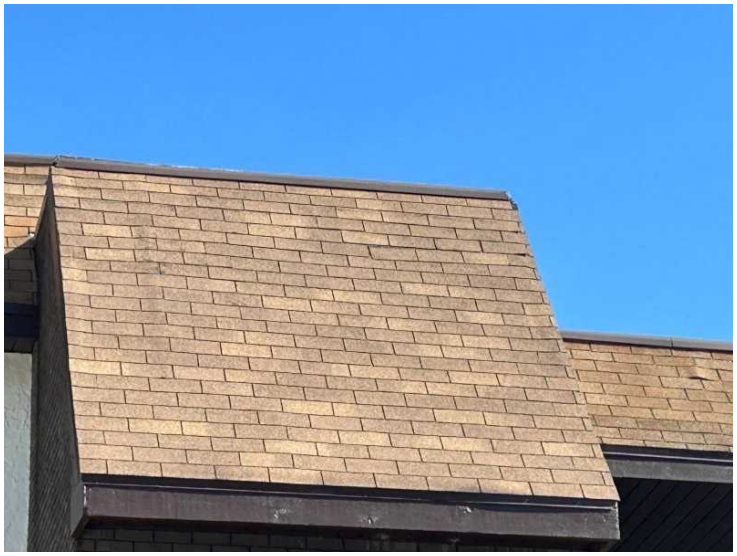
Roof Construction

3. **Roof Deck Attachment:** **Level A**
   Comments: Inspection verified 1/2" plywood roof deck attached with staples at a minimum of 6" on the edge & 12" in the field.

4. **Roof to Wall Attachment:** **Toe Nails**
   Comments: Inspection verified embedded straps fastened with less than three nails.
