Windstorm Mitigation Report (OIR-B1-1802)

Cypress Run Condominium Association, Inc.

Bldg 5, 5 Cypress Run, Units 51A-56C

As of 02-17-2026 | FPAT File# MUD2626471

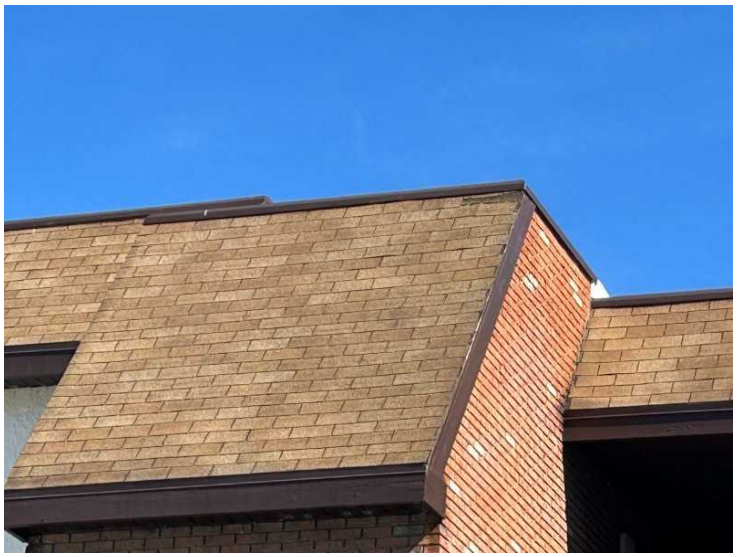
Roof Construction

3.	**Roof Deck Attachment:**	**Level A**
	Comments:	Inspection verified 1/2" plywood roof deck attached with staples at a minimum of 6" on the edge & 12" in the field.
